**Puckorius & Associates, Inc.**

**SUBJECT: EFFICACY OF A 0.3% CHLORINE DIOXIDE SOLUTION  
(PRODUCT KNOWN AS CDG SOLUTION 3000) FOR  
ALGAE CONTROL IN AN  
OPERATING COOLING TOWER WATER SYSTEM**

**PREPARED BY  
PAUL R. PUCKORIUS  
PUCKORIUS & ASSOCIATES, INC.  
ARVADA, COLORADO 80002**

**OCTOBER 6, 2010**

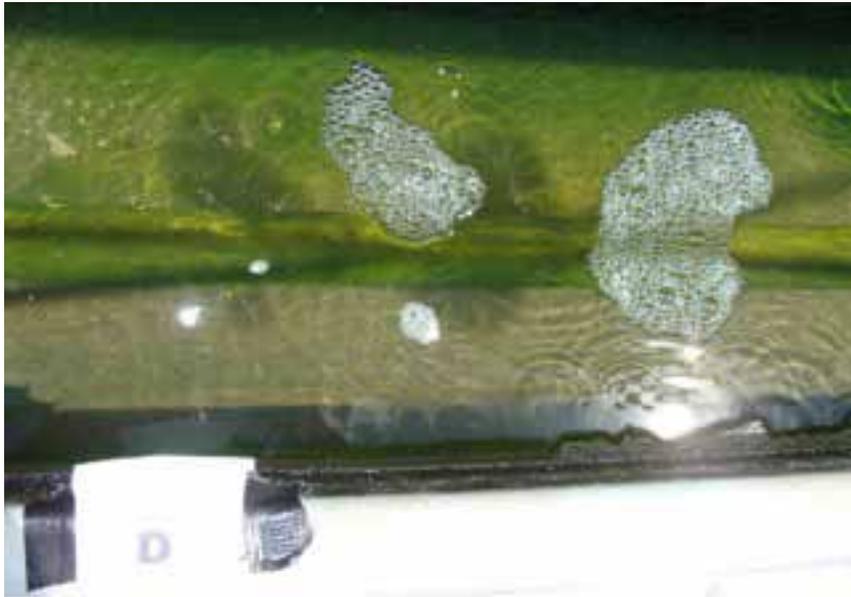
This demonstration was conducted for 30 days, from August 9, 2010 - September 7, 2010. The cooling tower did not receive any biocides or algacides for 6 days prior to the start. This allowed the algae to grow and accumulate significantly in the tower basin (Photo 4). The only algacide or biocide used during this demonstration was the CDG Solution 3000 (regular scale and corrosion inhibitors, which do not impact algae growth, were present).

**PHOTO 4.** Day 1, site D. Algae in basin and coating PVC pipe prior to Solution 3000 application. Direct measurement of the algae deposit was not possible since it washes away when disturbed, due to the flow of the water.

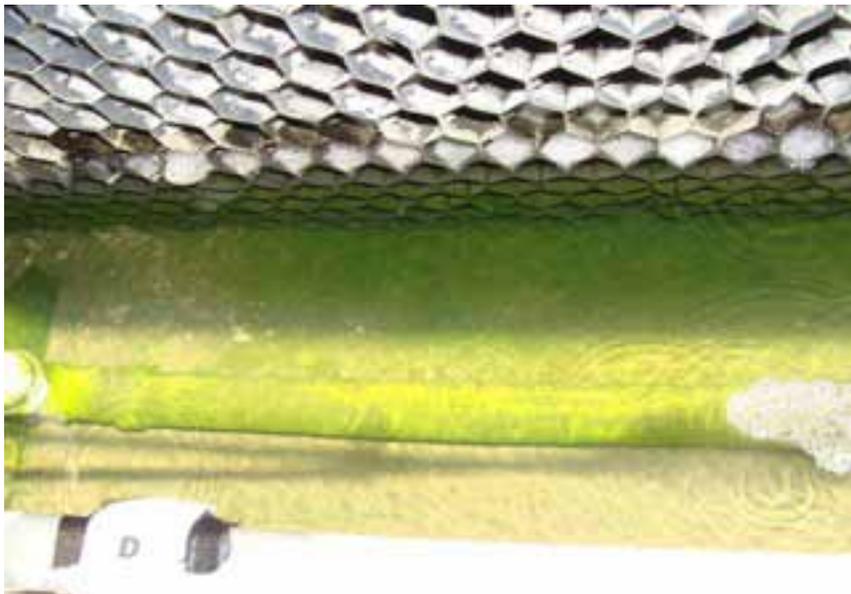
**PHOTO 5.** Day 1, site D. Significant algae growth in basin and coating PVC pipe prior to Solution 3000 application. This represented the “worst-case” site in the tower basin.

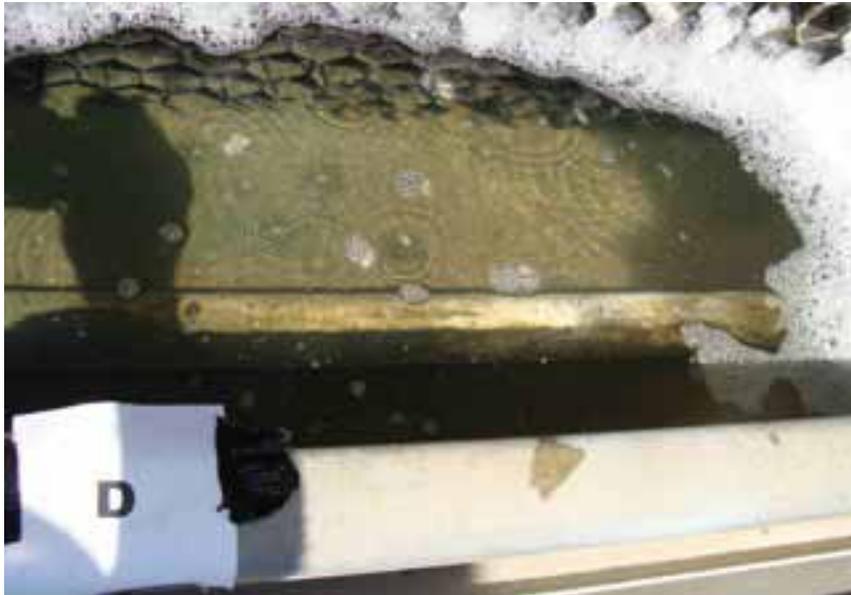
**The results of this evaluation clearly illustrated that CDG Solution 3000 is an effective algaecide for use in cooling tower water systems. Immediate and complete kill of algae occurred after the initial product application, which was illustrated by the green algae turning brown (Photos 5 – 6). Following the initial application, no significant algal re-growth was observed for the duration of the 30-day trial. After discontinuation of the CDG 3000, significant algae re-growth occurred within 7 days.**

**PHOTO 6.** Day 1, site D. Two hours after initial 50 mg/L slug dose of CDG Solution 3000. Nearly complete destruction of the algae was achieved, as evidenced by the color changing from bright green to brown.

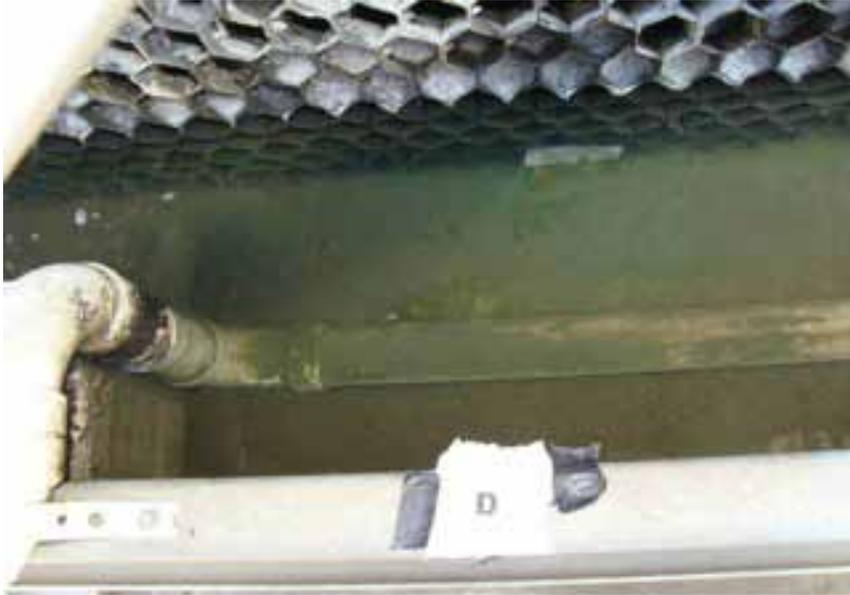
**PHOTO 8.** Day 9, site D. Sediment accumulation in the basin is shown.

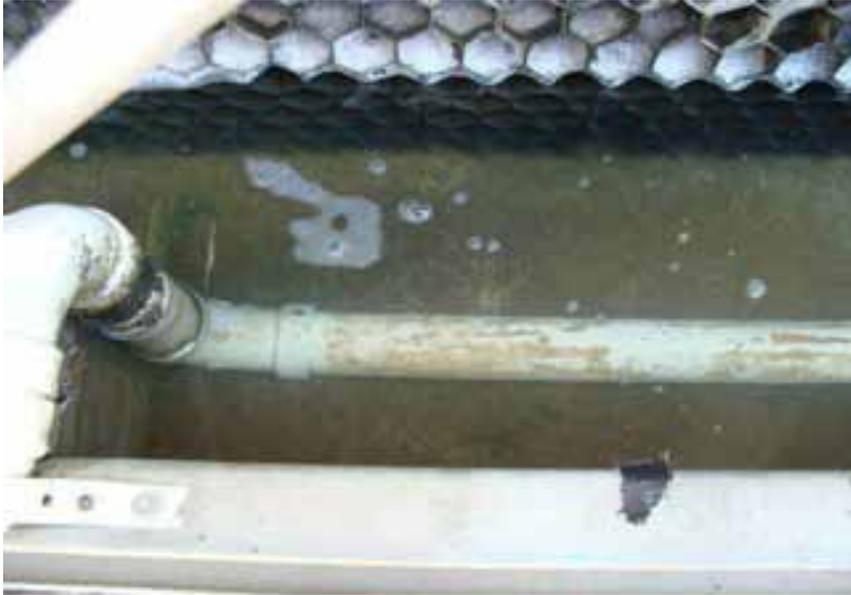
**PHOTO 10.** Day 16, site D. The tower was vacuumed on day 15, as part of its regularly scheduled maintenance, removing much of the dead algae and sediment.

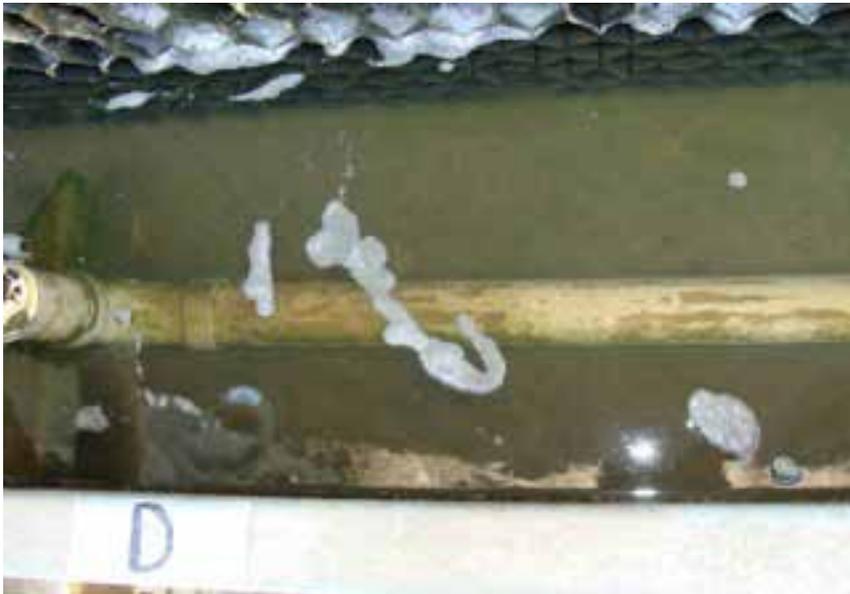
**PHOTO 13.** Day 30, site D. Significant re-growth was not observed at this site.

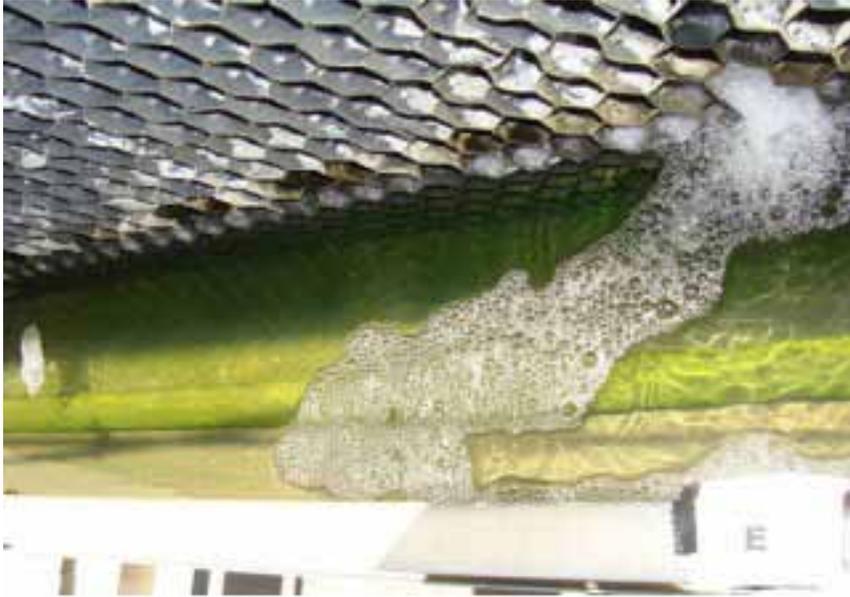
**PHOTO 14.** Day 1, Site E, prior to Solution 3000 application. This site was in the same basin as site D, in the middle of the basin approximately 7 feet away.

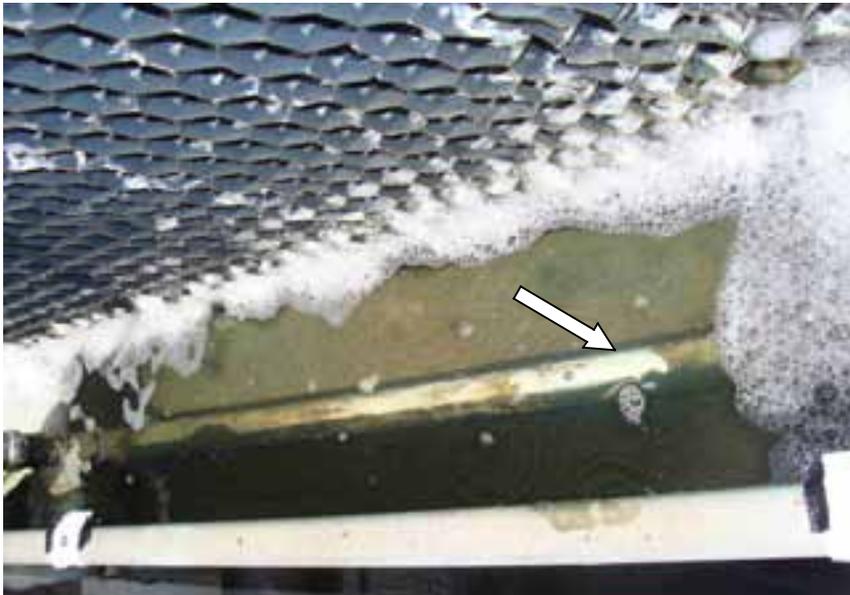
**In order to provide greater resolution in assessing the effectiveness of the Solution 3000, a small section of white PVC pipe at Site E was brushed clean on Day 1 of the trial, removing the dead algae and sediment (Photo 15). As shown in Photos 16 – 18, this section remained clean for the initial 14 days, at which time the basin was vacuumed as part of its regularly scheduled maintenance. Following the cleaning process, the white pipe remained clean for the balance of the evaluation, as shown in Photos 19 - 22. The impact of discontinuing the Solution 3000 feed is shown in Photo 23, which was taken 7 days after the conclusion of the trial. Significant algae re-growth is shown in this photo (compare to Photo 22).**

**PHOTO 15.** Day 1, Site E. Two hours after initial slug dose. A small section of PVC pipe was brushed clean (shown by arrow) to provide more resolution in assessing algae re-growth.

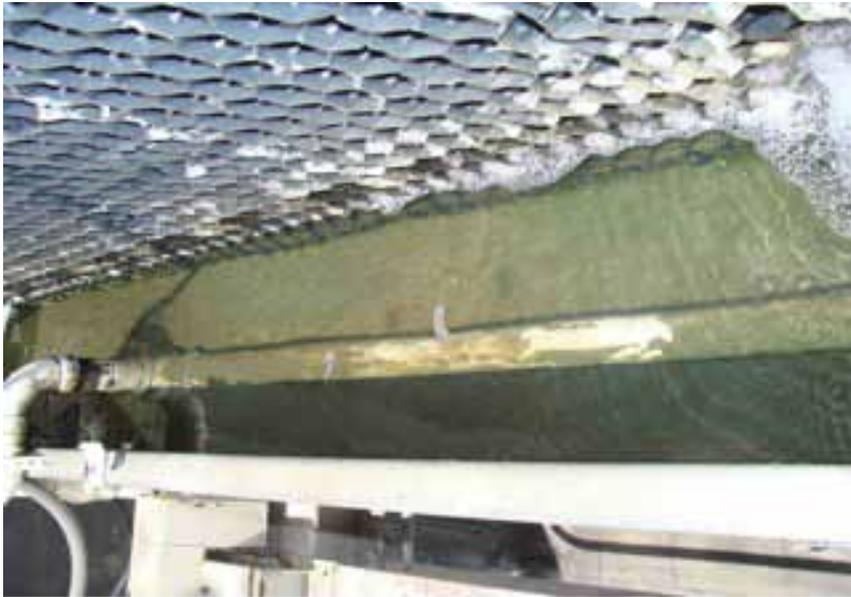
**PHOTO 18.** Day 13, Site E. Algae re-growth was not observed on the brushed-off section of PVC pipe.

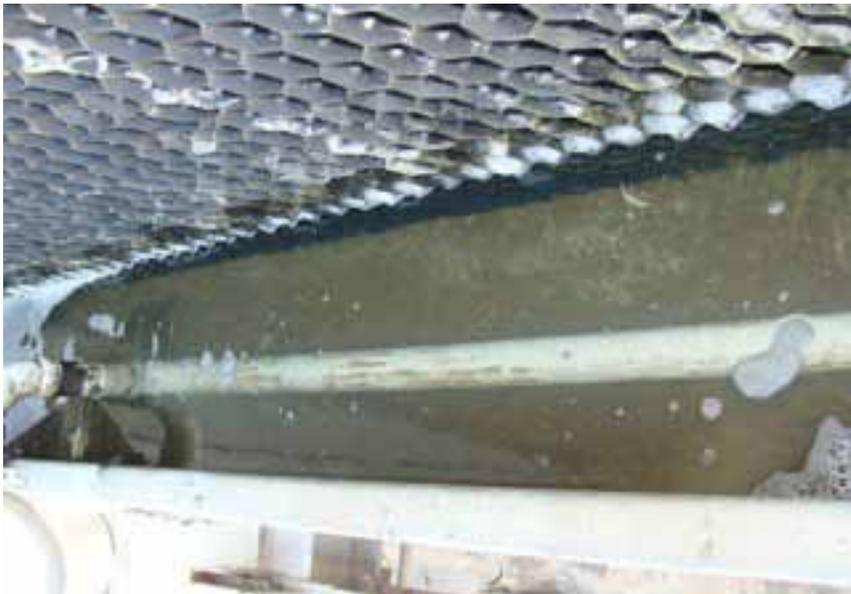
**PHOTO 19.** Day 16, Site E. Basin was cleaned the prior day.

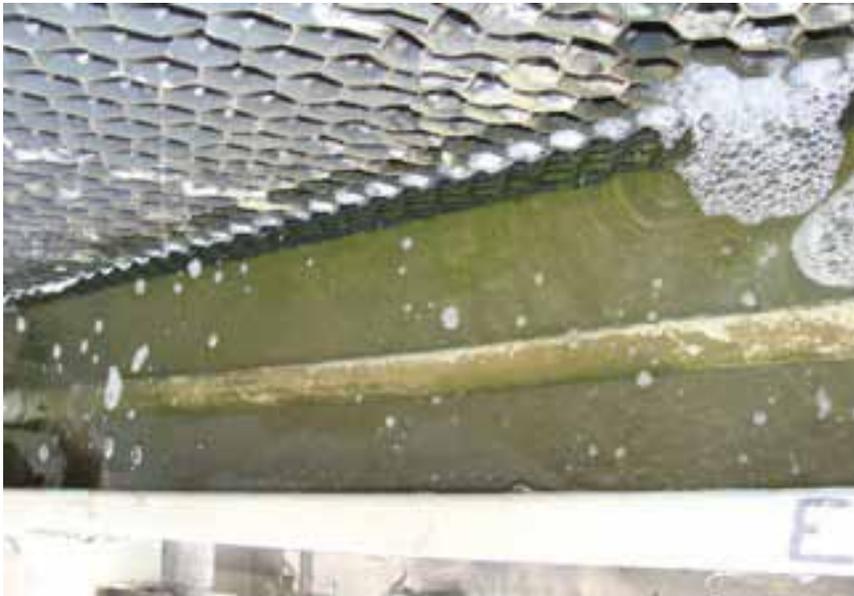
**PHOTO 23.** Site E, 7 days after Solution 3000 feed was discontinued.
