THE USE OF CHLORINE DIOXIDE TO CONTROL BIOFOULING IN AN ORGANIC BEEF FARM WATER SYSTEM

Dean Gregory, PhD (CDG Environmental, LLC)

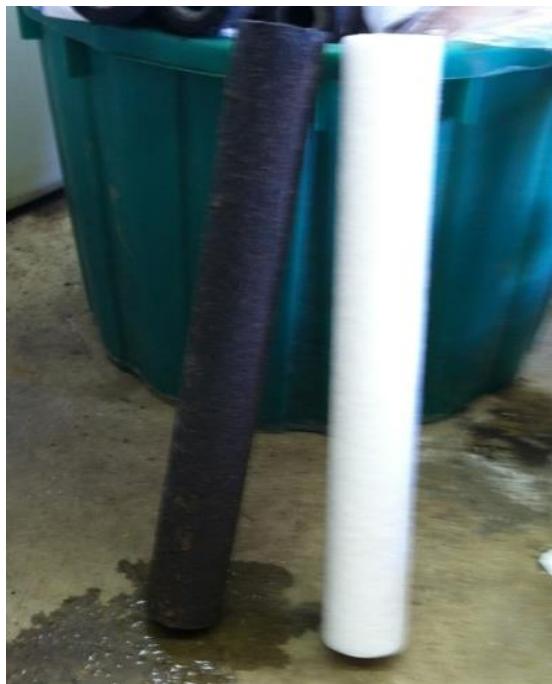
Figure 1. A 20- μm filter after 5 days of service (left), prior to the implementation of chlorine dioxide, compared to a new filter. The black color of the biofilm is indicative of the presence of sulfate-reducing bacteria.

An organic beef farm in northern Colorado was experiencing excessive biofilm growth on the 20- μm filters through which its cattle drinking water is pumped. The source is groundwater, pumped from a 70-foot well into a 2,000-gallon holding tank, and from there pumped (16 gpm) through a bank of four 20- μm , spiral-wound filters and then distributed to the cattle drinking troughs. Some of the water is also used for plant processes. The excessive biofilm growth on the filters was evidenced by a significant decrease in house-water pressure and flow rate and required the farm to replace the filters approximately every 5 days at a cost of \$800/month.

Bacterial inactivation. Prior to the start-up of the ClO₂ system, it was clear from the rapid growth of biofilm on the filters that there was a significant bacterial population in the well water. From the sulfate level in the water (14 mg/L) and the distinctive black color of the filters, at least some of these appeared to be sulfate reducing bacteria (SRB), which would have thrived in the anaerobic conditions within the layers of biofilm. As noted in Table 1 and confirmed in Table 2 below, coliform bacteria, including *E. coli*, were also detected in the raw well water samples. The addition of chlorine dioxide, as shown in Table 2, reduced the counts of all aerobic and coliform bacteria to zero, in a sample collected downstream of the 20-μm filters. Although anaerobic bacteria such as SRB were not measured in that sample, it is a safe assumption that they were also completely inactivated, as evidenced by the absence of biofilm on the filters.

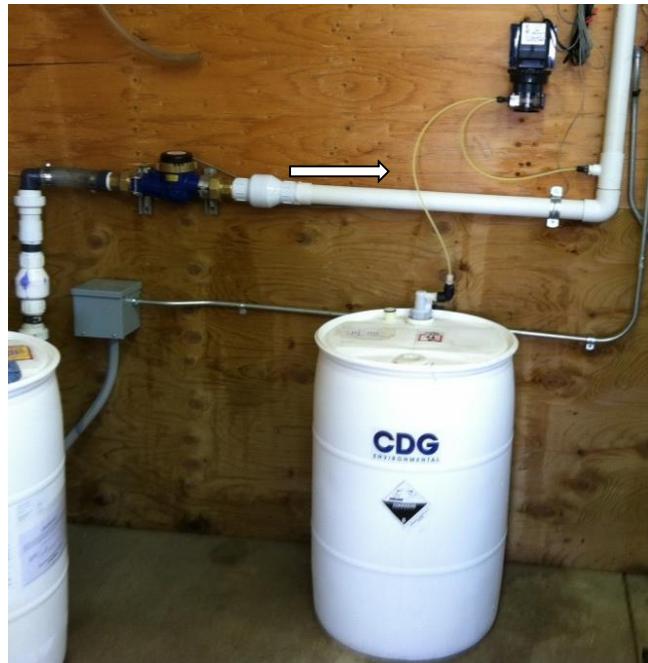
Figure 2. Chlorine dioxide feed system. The 0.3% aqueous solution is contained in the white 55-g drum. Arrow shows the direction of water flow. Peristaltic pump is in the upper right corner.

Chlorine dioxide system. The source of ClO₂ was a 0.3 percent aqueous solution (3000 mg/L) that was virtually free of unwanted contaminants such as free chlorine and chlorite ion (*Solution 3000™*, www.cdgenvironmental.com). *Solution 3000* is a ready-to-use, pure chlorine dioxide solution and requires no mixing or activation of chemicals. Using a standard wall-mounted peristaltic pump (Stenner Pumps, model 85MHP40), it was fed from a 55-gallon drum and injected into a 2" PVC line conveying the well water to the 2,000-gallon holding tank (Figure 2). The pump head is equipped with Santoprene™ tubing pre-installed by the manufacturer. Santoprene™, also known as thermoplastic rubbing tubing, provides excellent mechanical properties over a wide temperature range and is highly chemically resistant, an important characteristic for pumping a chlorine dioxide solution. As suggested by the manufacturer, the tubing is replaced every 3-4 months. The 55-gallon drum comes equipped with a quick-connect fitting (Colder Products Company) that allows easy connection of the suction tubing to the drum and minimizes operator contact with chlorine dioxide gas.

The goal in dosing the chlorine dioxide was to achieve a residual of 0.3 – 0.4 mg/L at the 20-µm filters, downstream of the holding tank. Given the relatively low ClO₂ demand of the groundwater and short detention time in the holding tank (approximately 30 min.), it was

found that an applied dose of 0.70 mg/L was sufficient to achieve the target residual at the filters. Although the 30-min. detention time in the tank is relatively short, it is more than adequate for ClO₂ to inactivate a large spectrum of microorganisms, particularly bacteria (99.9% inactivation of most bacteria can be achieved at a low dose within 60 seconds, for example). Chlorine dioxide residuals were measured using the glycine-DPD method (equivalent to Standard Methods, 4500-ClO₂-d).

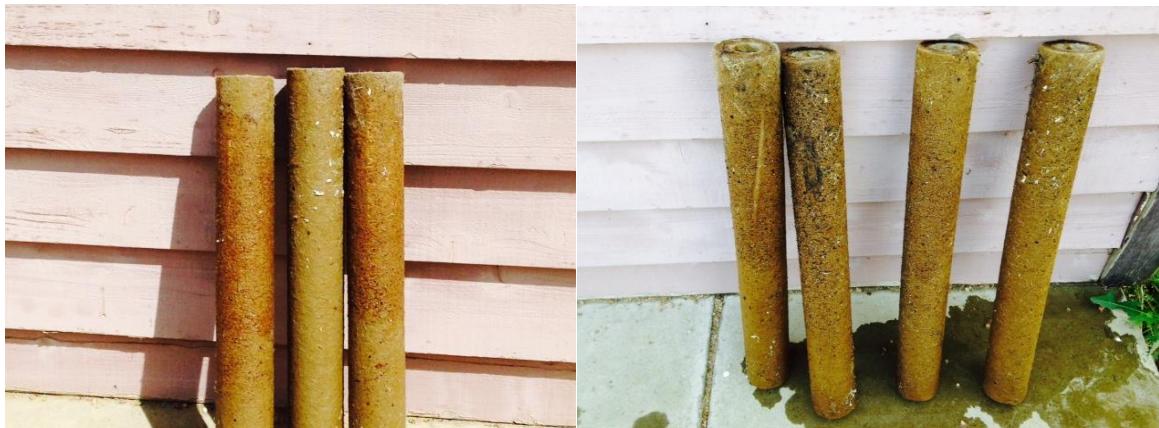
Figure 3. The 20-μm filters approximately 2 weeks (left) and 6 weeks (right) after the start-up of the ClO₂ system. Virtually no change was detected in the performance of these filters during this period (contrast with filter in Figure 1 after 5 days, prior to ClO₂ addition).

Filter performance. A significant improvement in filter performance—in terms of no increase in head loss across the filters—was observed within a few days of starting up the ClO₂ system. As noted previously, prior to the implementation of ClO₂ the 20-μm filters needed to be replaced every 4-5 days and were typically clogged with black biofilm (Figure 1). After two weeks of chlorine dioxide application the filters were visually inspected and no significant biofilm development was observed (Figure 3). The light-brown color of the filters in Figure 3 was due to the accumulation of suspended solids and had no effect on the head loss across the filters. After another 4 weeks (6 weeks total operation) the filters were removed and inspected again. Their condition was virtually unchanged from the 2-week inspection, as shown in Figure 3.

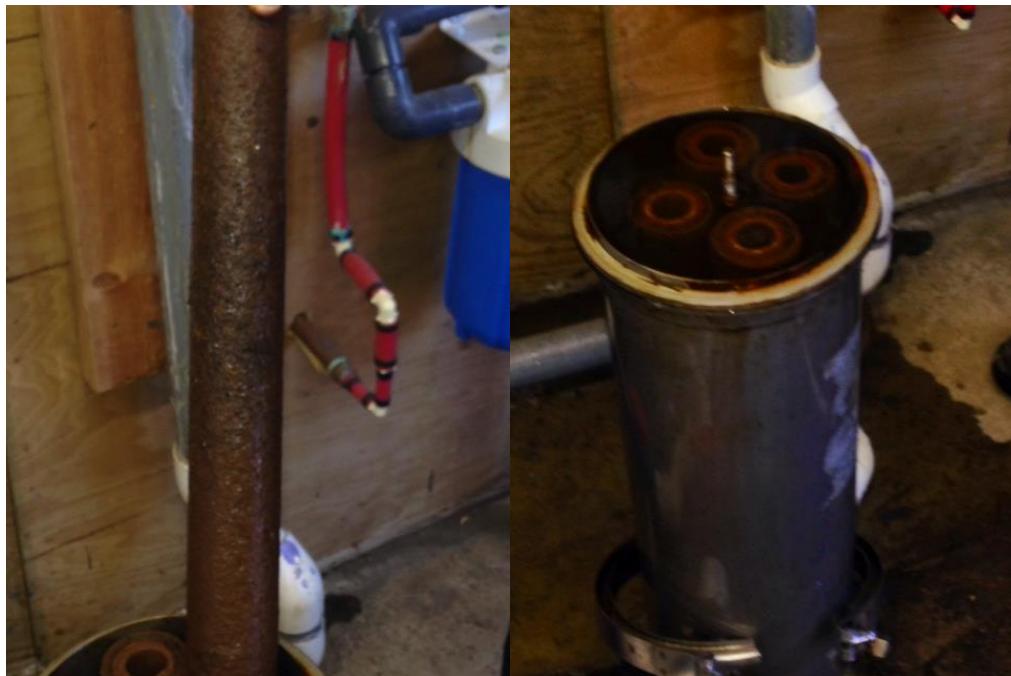
Figure 4. A 20- μm filter after approximately 5 months of service (left), following implementation of the chlorine dioxide system. The pressurized filter housing unit is shown on the right.

Following the positive results from the initial 6-week trial, although no significant decrease in performance was observed, the filters were replaced. With a continual chlorine dioxide residual present, in the range of 0.4 – 0.5 mg/L, the next set of four filters remained in operation for approximately 5 months. Even after this duration (compared to 5 days prior to ClO₂) head loss due to biofilm growth was not an issue. The filters had, however, accumulated a significant amount of suspended solids, as shown in Figure 4, which prompted their replacement.
