**Puckorius & Associates, Inc.**

**SUBJECT: EFFICACY OF A 0.3% CHLORINE DIOXIDE SOLUTION  
(PRODUCT KNOWN AS CDG SOLUTION 3000) FOR  
ALGAE CONTROL IN AN  
OPERATING COOLING TOWER WATER SYSTEM**

**PREPARED BY  
PAUL R. PUCKORIUS  
PUCKORIUS & ASSOCIATES, INC.  
ARVADA, COLORADO 80002**

**OCTOBER 6, 2010**

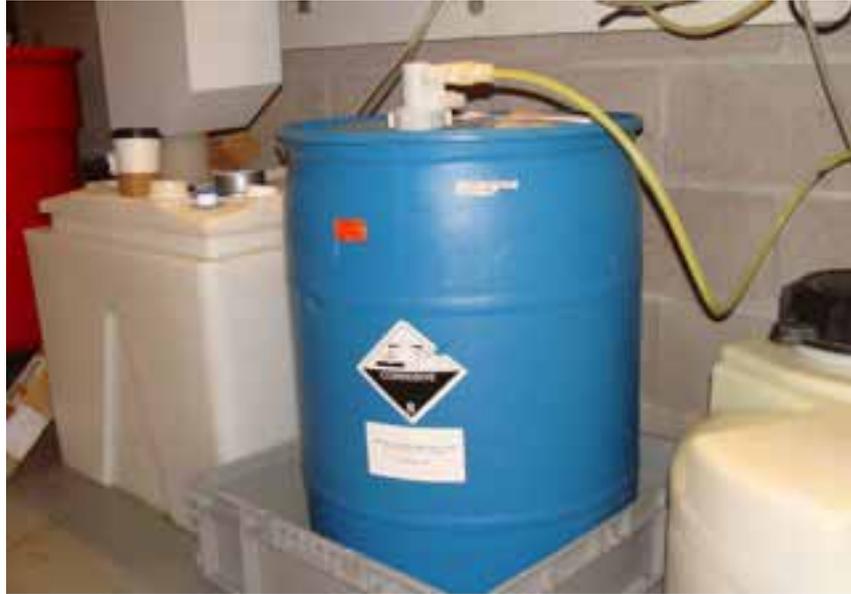
**Figure 1. CDG Solution 3000 being fed from 30-g container during the trial.**

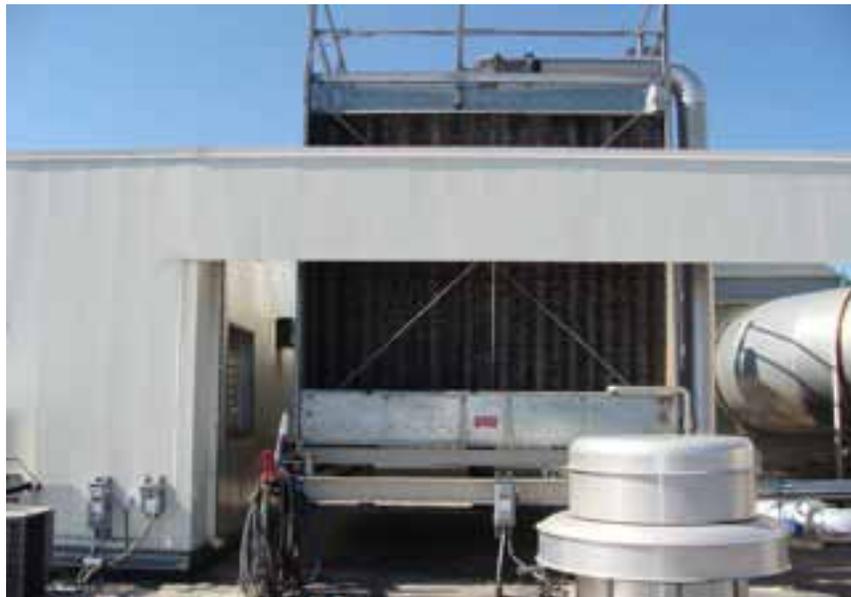
**The cooling tower is constructed of galvanized steel and manufactured by Marley Cooling Tower Company. It is a cross-flow tower with PVC fill and PVC mist eliminators and rated at 500 tons. It supplies cool water at 70-75°F and receives warm water at 80-85°F depending upon the outside temperature and humidity. The circulation rate of this semi-closed loop system (make-up water is introduced regularly) is approximately 800 gallons per minute with reduced flow during the weekends. It operates 24/7 and has a total system volume of approximate 1500 gallons. It is connected with mild steel piping to a chiller with copper tubes.**

**PHOTO 1.** Cooling tower general view.

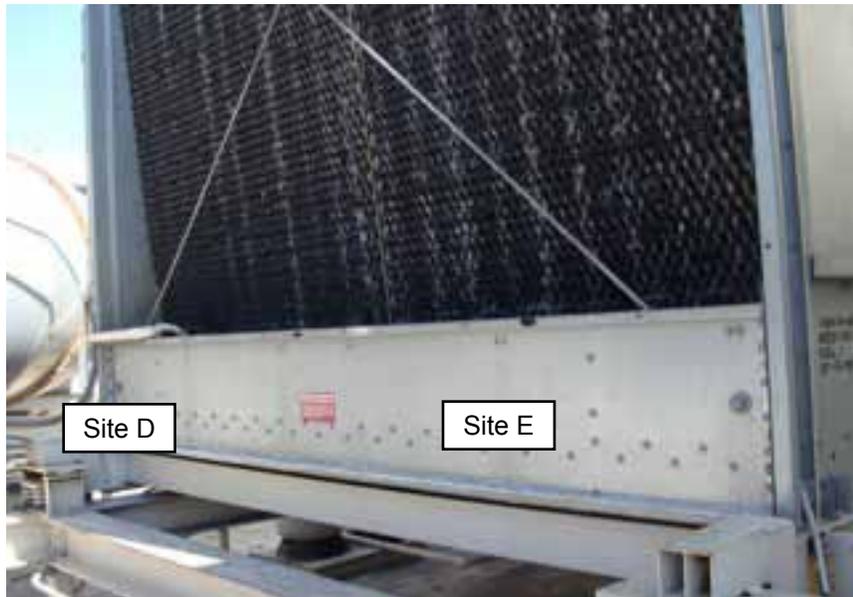
**PHOTO 2.** Close-up of cooling tower basin. Algae photos were taken by standing on the I-beam shown in the foreground on the left side. Site D is the far left side of this basin. Site E is in the middle.

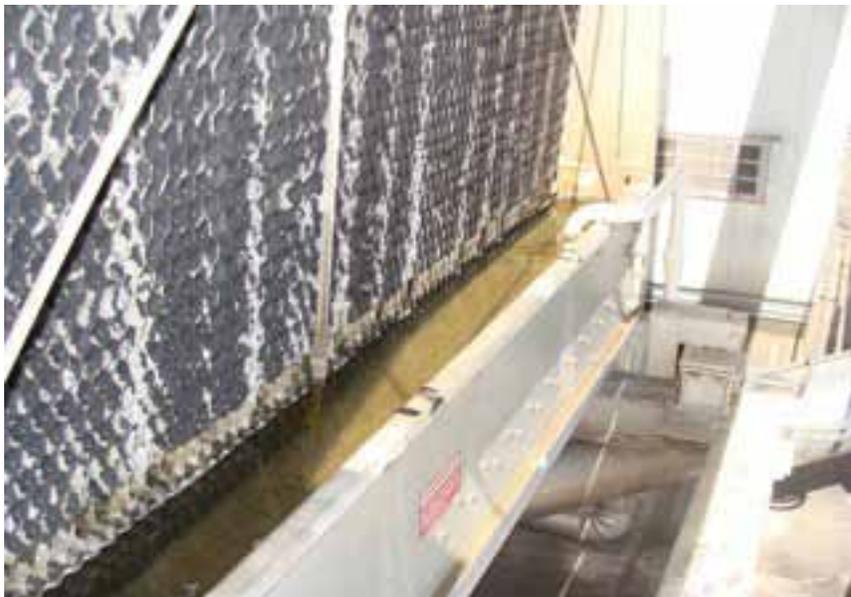
**PHOTO 3.** Side/top view of cooling tower basin showing water in basin.

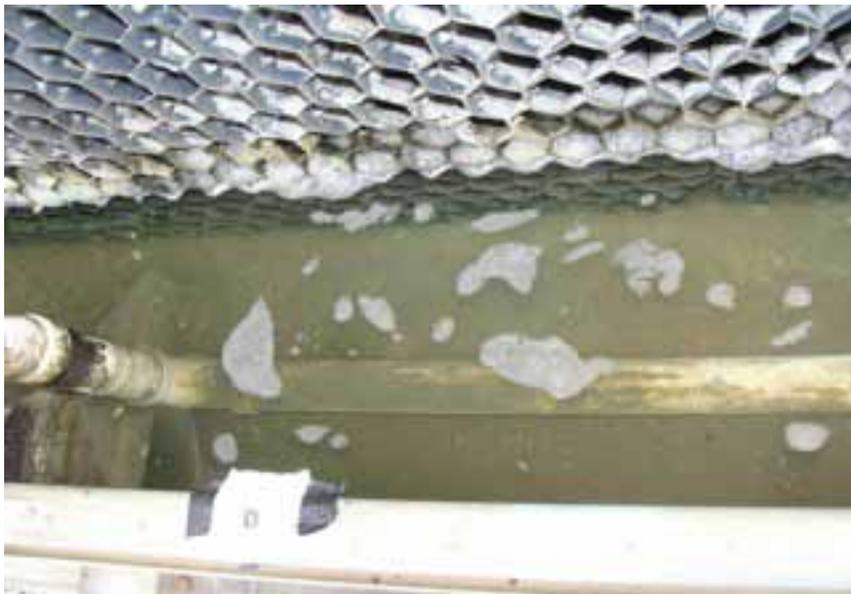
**PHOTO 7.** Day 4, site D.

**Photos 4 – 14 and 15 – 23 document the initial algae destruction and subsequent control over the duration of the 30-trial for Sites D and E, respectively. The initial conditions are shown in Photos 4, 5, and 14. Overall, after the initial application of Solution 3000, no significant algae re-growth was observed in the basin for the duration of the 30-d trial. The initial slug dose of 50 mg/L dramatically impacted the algal biofilm, as shown in Photos 6 and 15. It should be noted that, as is typical for all cooling towers, some sediment accumulated in the basin during the trial (for example, compare the PVC pipe in Photos 7 and 9). However, this accumulation did not appear to be related to algae and did not possess the distinctive bright green color shown in the initial photos.**

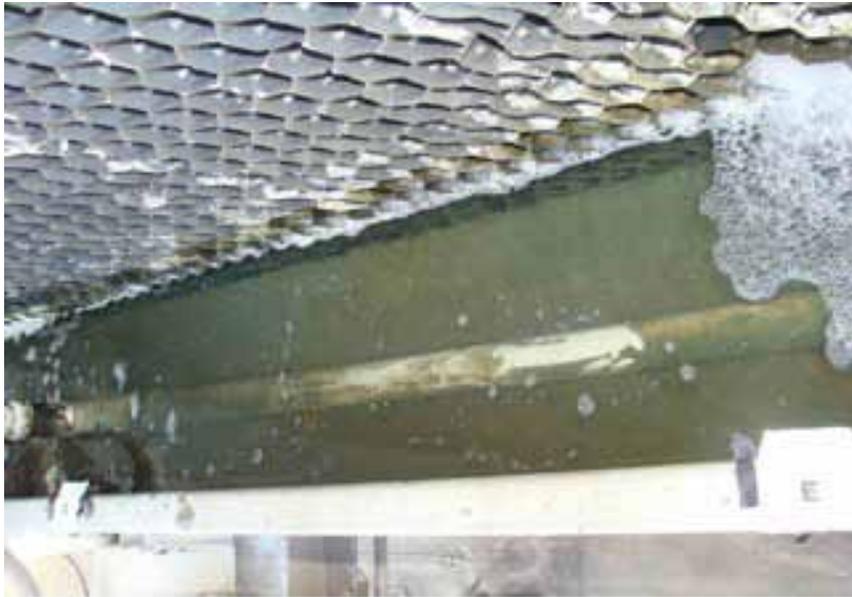
**PHOTO 16.** Day 4, Site E.

**In order to provide greater resolution in assessing the effectiveness of the Solution 3000, a small section of white PVC pipe at Site E was brushed clean on Day 1 of the trial, removing the dead algae and sediment (Photo 15). As shown in Photos 16 – 18, this section remained clean for the initial 14 days, at which time the basin was vacuumed as part of its regularly scheduled maintenance. Following the cleaning process, the white pipe remained clean for the balance of the evaluation, as shown in Photos 19 - 22. The impact of discontinuing the Solution 3000 feed is shown in Photo 23, which was taken 7 days after the conclusion of the trial. Significant algae re-growth is shown in this photo (compare to Photo 22).**
